Error Sequence^{1,2} and the Loss of 88 Souls on Alaska Airline's Flight 261

Thomas C. (Tom) Mawhinney

This is a *Working Paper* presented at meetings of **Behavior Safety Now**, September 27, 2007 in Kansas City, MO.

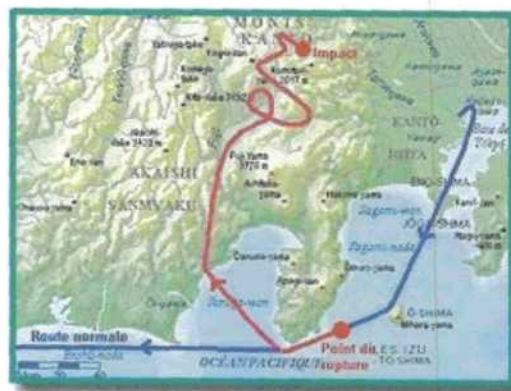
Figure 5. Flight path following explosive decompression depicted in red.

Without its vertical stabilizer, as we learned above, control of the aircraft is difficult if not impossible. Valiant efforts on the part of pilots to control the plane's flight path and return to the airport appear in the approximately 30 minute flight path depicted in Figure 5.

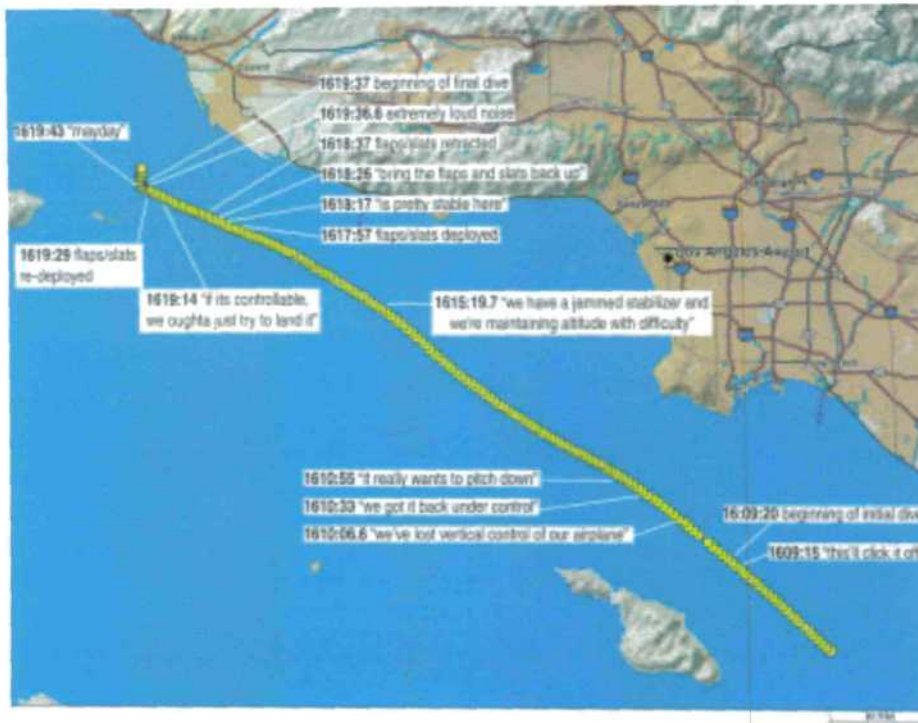
Figure 7. The flight path of Alaska Airlines Flight 261, starting about 1609 (about the time of the initial dive) and ending about 1620 (about the time of the second and final dive).

The straight path of Alaska Airlines Flight 261 (Figure 7) and the meandering path of Japan Airlines Flight 123 (Figure 5) clearly implicate loss of vertical pitch control and altitude of Flight 261 and lateral directional control (yaw) in the case of Flight 123. This would be expected, meandering, if a vertical stabilizer and rudder were destroyed.

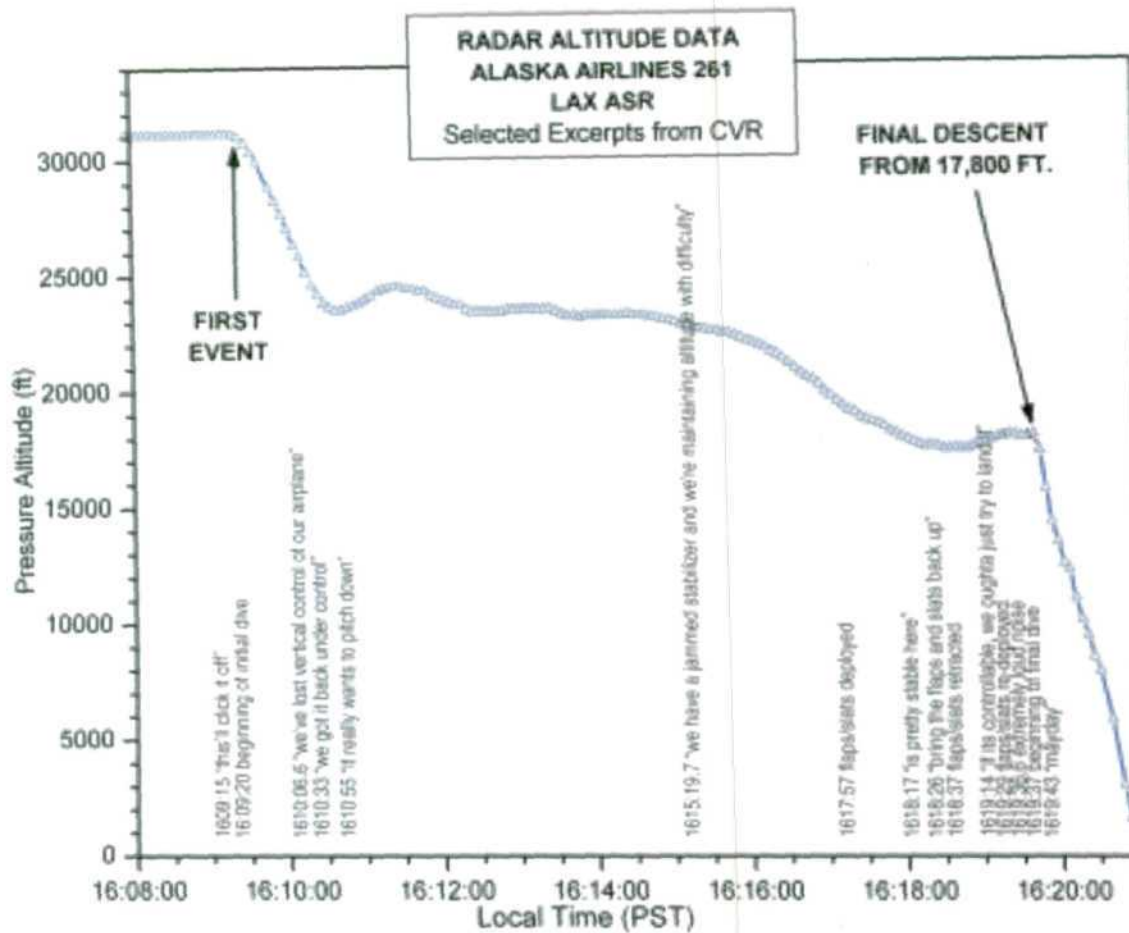
Figure 8. Radar altitude data and selected ATC transmissions from about 1609 to 1620.
Source: NTSB, 2002, p. 6.

The elevation and vertical changes, Figure 8, during the relatively straight ground track graphed in Figure 7, on the other hand, clearly indicate, without any other information, that Flight 261's problem involved the pilots' loss of control over the plane's altitude. That loss of control could be due to one of two failures: a.) loss of thrust (and air speed) and/or b.) loss of longitudinal pitch control due to a loss of control over the horizontal stabilizer.

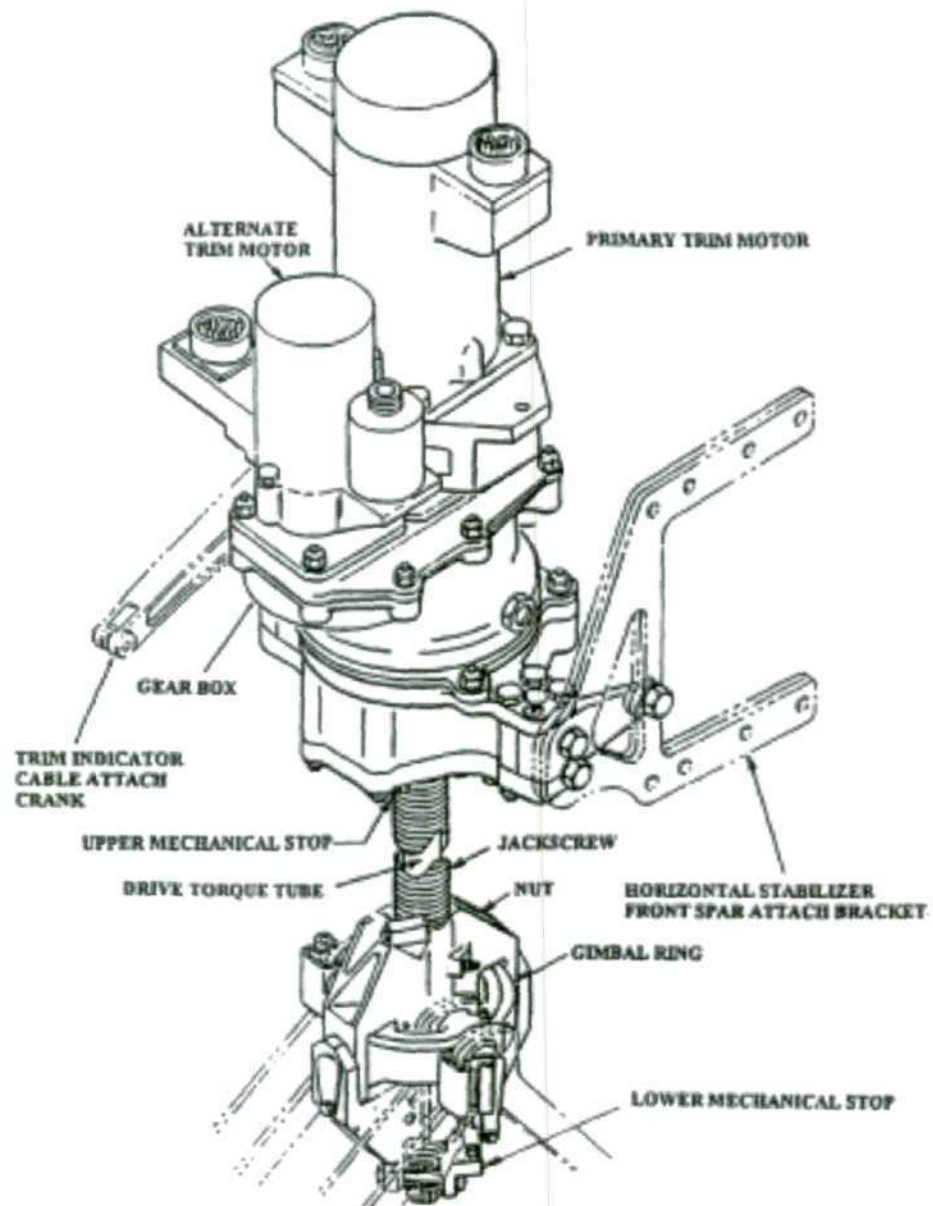
Figure 11 Detailed schematic of the longitudinal trim actuating mechanism. Source: Figure 6 NTSB 2002, p. 16.

A Safety Board review of the April 15, 1965, DC-9 Flight Controls System Fault Analysis Report (revised July 14, 1997) indicated that no contingency for the complete loss of the acme nut threads was incorporated into the design for the longitudinal trim control system. According to the fault analysis, the acme nut was designed with a softer material than the acme screw and its threads were designed to wear. Acme nut threads are made of an aluminum-bronze alloy and are about 0.15 inch thick at the minor diameter when new. The acme screw threads are made of case-hardened steel. (NTSB, 2002, p. 22).

On-scene visual and tactile inspections by Safety Board metallurgists of the acme screw's threaded areas [of the accident aircraft] found no evidence of grease in any condition, either semi-fluid (that is, fresh) or solid/dry (that is, old or degraded), or other lubricants in the central "working region" of the screw threads.¹²⁹ Laboratory examinations found small flakes of dried and hardened grease attached to some of the thread remnants in this region. The acme screw's lower threads (which are outside of the working region) were found partially packed with a mixture consistent with sand and grease. (Figure 14 [Figure 13 in this paper] shows the sand/grease mixture packed between the acme screw's lower threads.) Parts of the acme screw's upper six to eight threads had an oily sheen, and small deposits of greaselike material were found between the threads. (NTSB, 2002, p. 69)
